DRAFT  
NATURAL RESOURCES EVALUATION

Florida Department of Transportation

SR 684 (Cortez Bridge and Approaches) PD&E Study

Financial Management Number: 430204-1

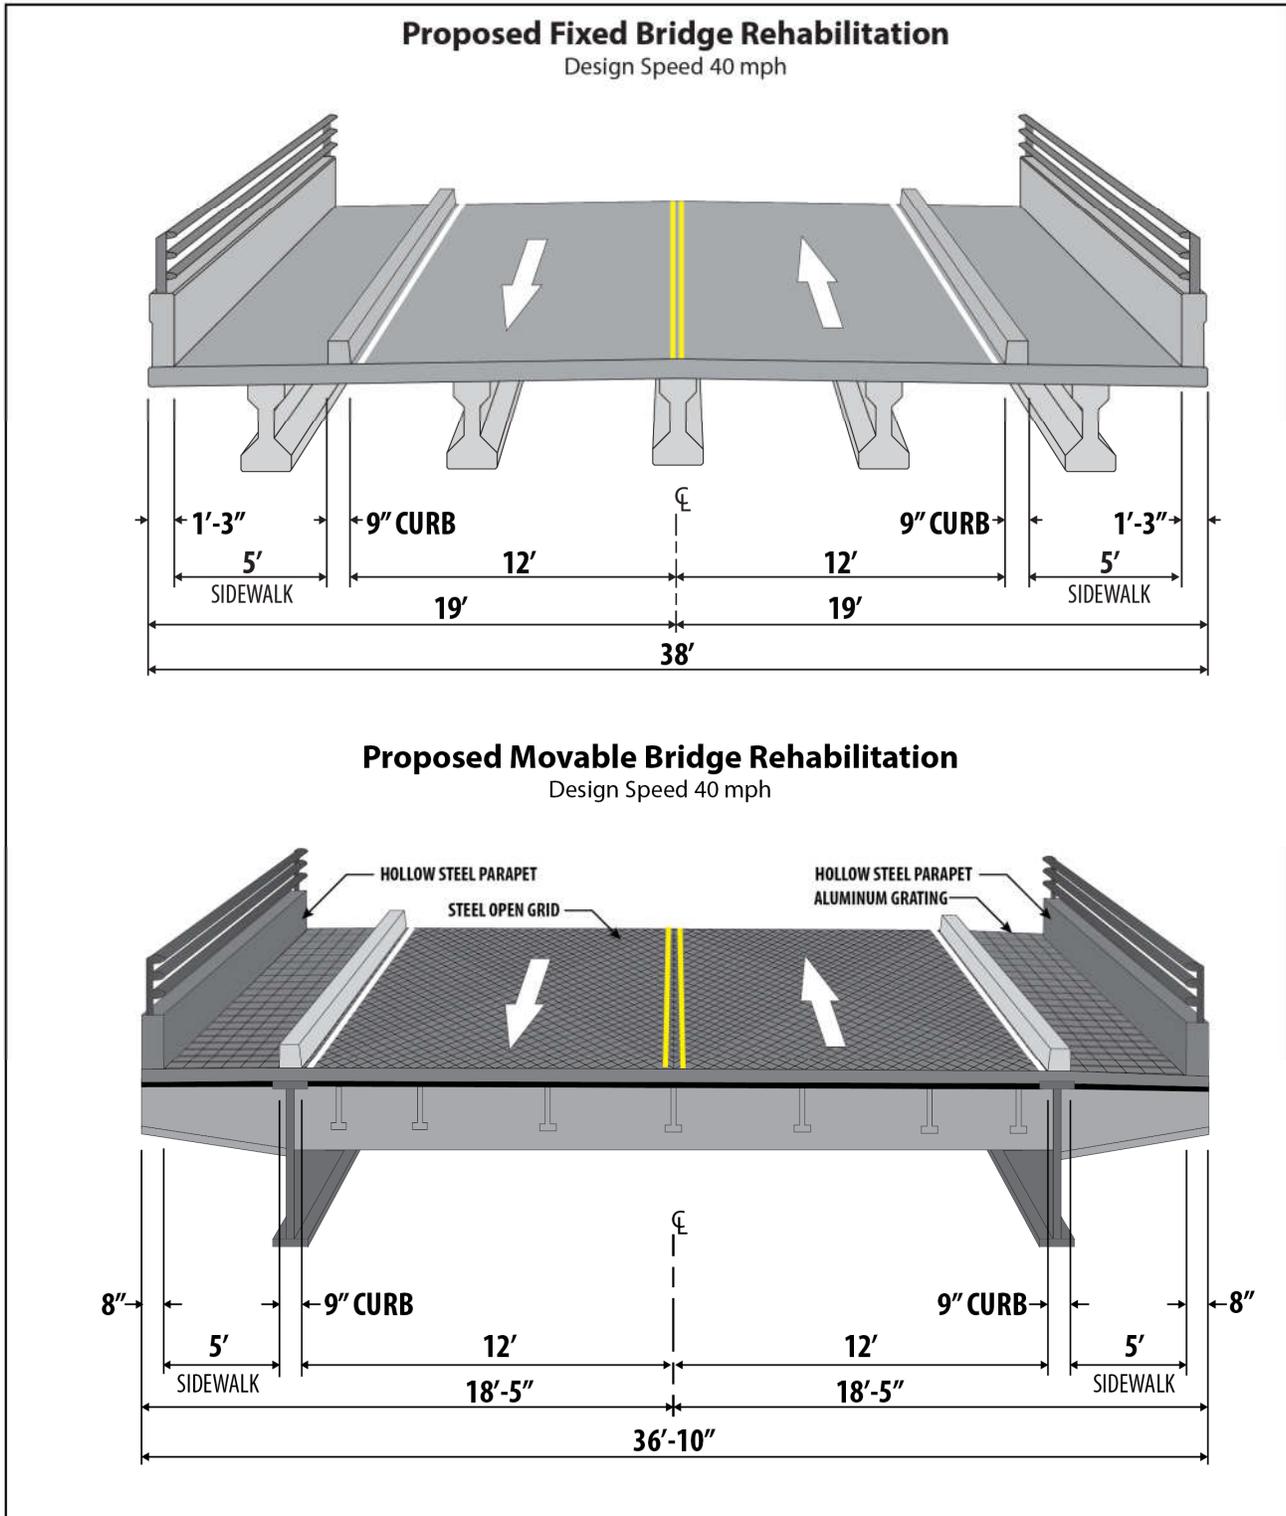
**Figure 2-1: Proposed Rehabilitation Typical Sections**

The Rehabilitation Alternative provides the necessary rehabilitation and repair of the existing bridge to keep it operating in a safe condition and extends the service life by an additional 25 years. The bridge's existing design speed of 40 miles per hour (mph) and posted speed of 35 mph will remain unchanged by this alternative. This alternative includes repairing the concrete, replacing all the concrete beams and the entire deck, installing cathodic protection pile jackets, installing 10 crutch bents, replacing the fender system, replacing the electrical and mechanical systems, repairing and painting the bascule span steel, and other repairs to extend the service life by 25 years and avoid the need to post the bridge for weight restrictions. In addition, the existing 9 inch (in) high brush curbs and non-crash tested bridge railings will be replaced. A 32-in vertical shape traffic barrier with an aluminum bicycle bullet railing will be constructed at the back of sidewalk as shown in **Figure 2-1**. In order to replace the superstructure, a temporary bridge will be constructed, avoiding the need for extended bridge closure and detours. Replacement of the bridge would be required at the end of the 25-year period.

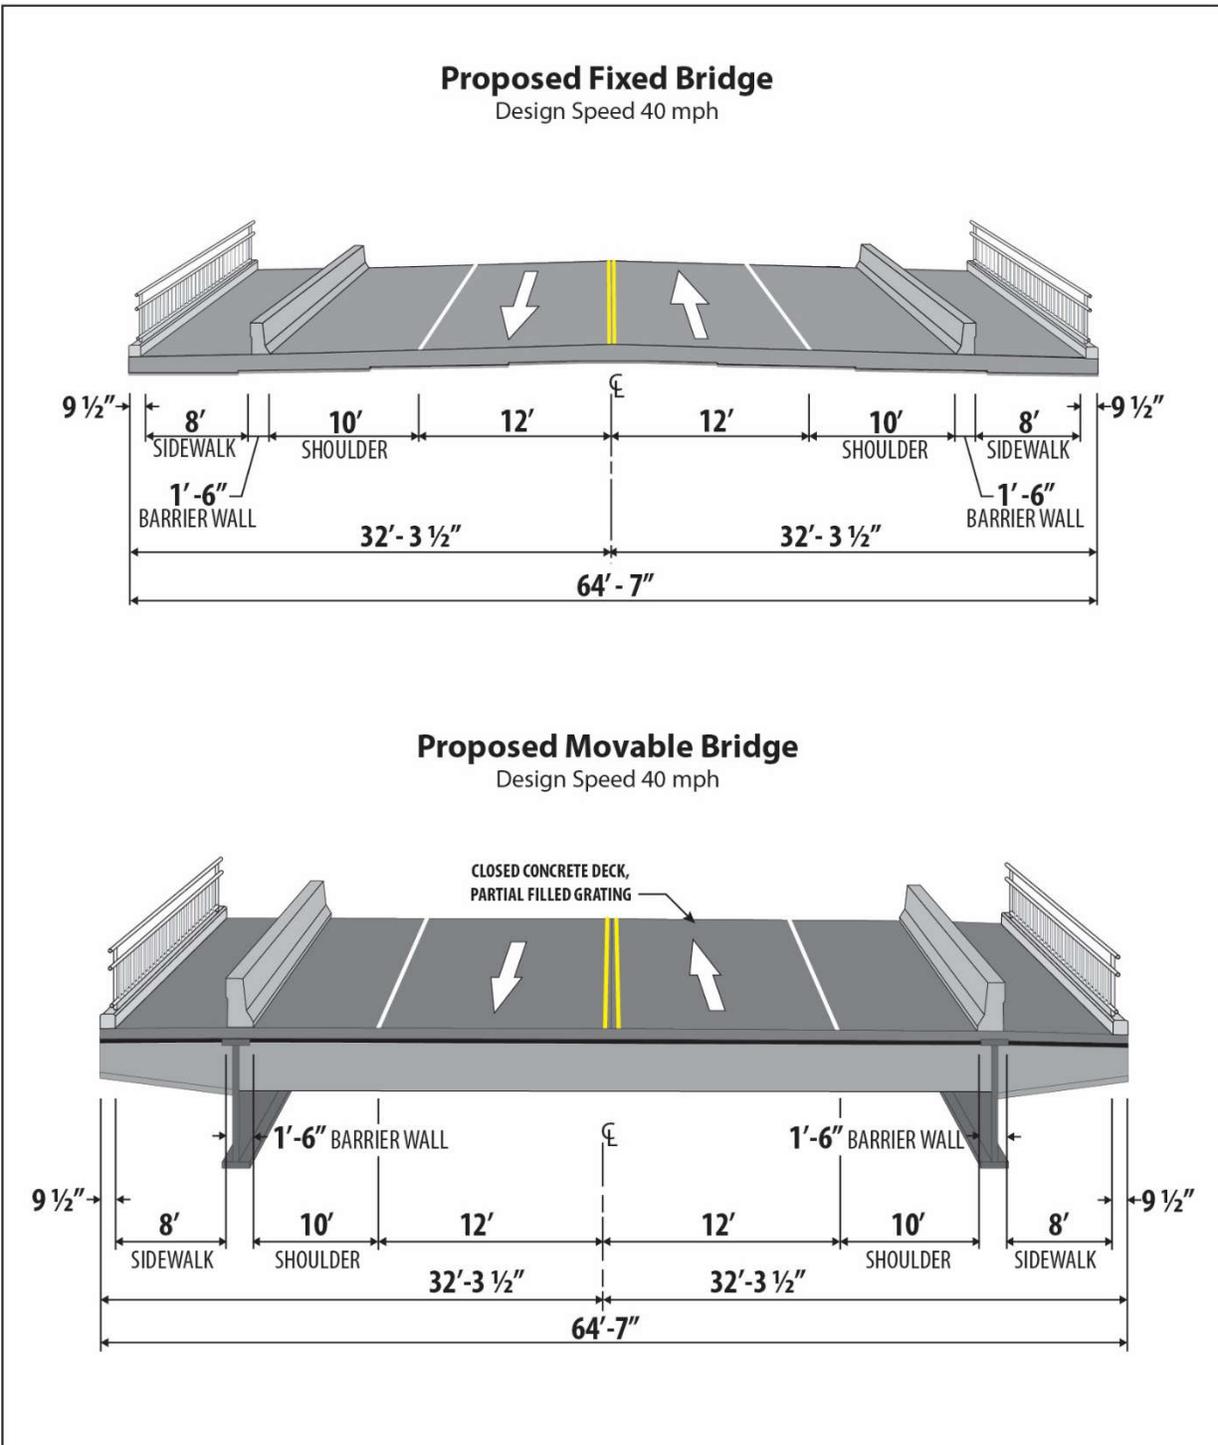
**Figure 2-2: Initial Proposed Replacement Typical Sections**

All bridge replacement alternatives include the same proposed typical section described previously and are summarized here:

The Low-level Bascule Alternative (North Alignment) would replace the existing Cortez Bridge with a new low-level bascule structure similar to the existing structure, with a 21-ft vertical navigational clearance (above MHW) when the bridge is closed. The new structure would be built 9 ft to the north of the existing structure, utilizing the proposed typical sections shown in Figure 2-2.

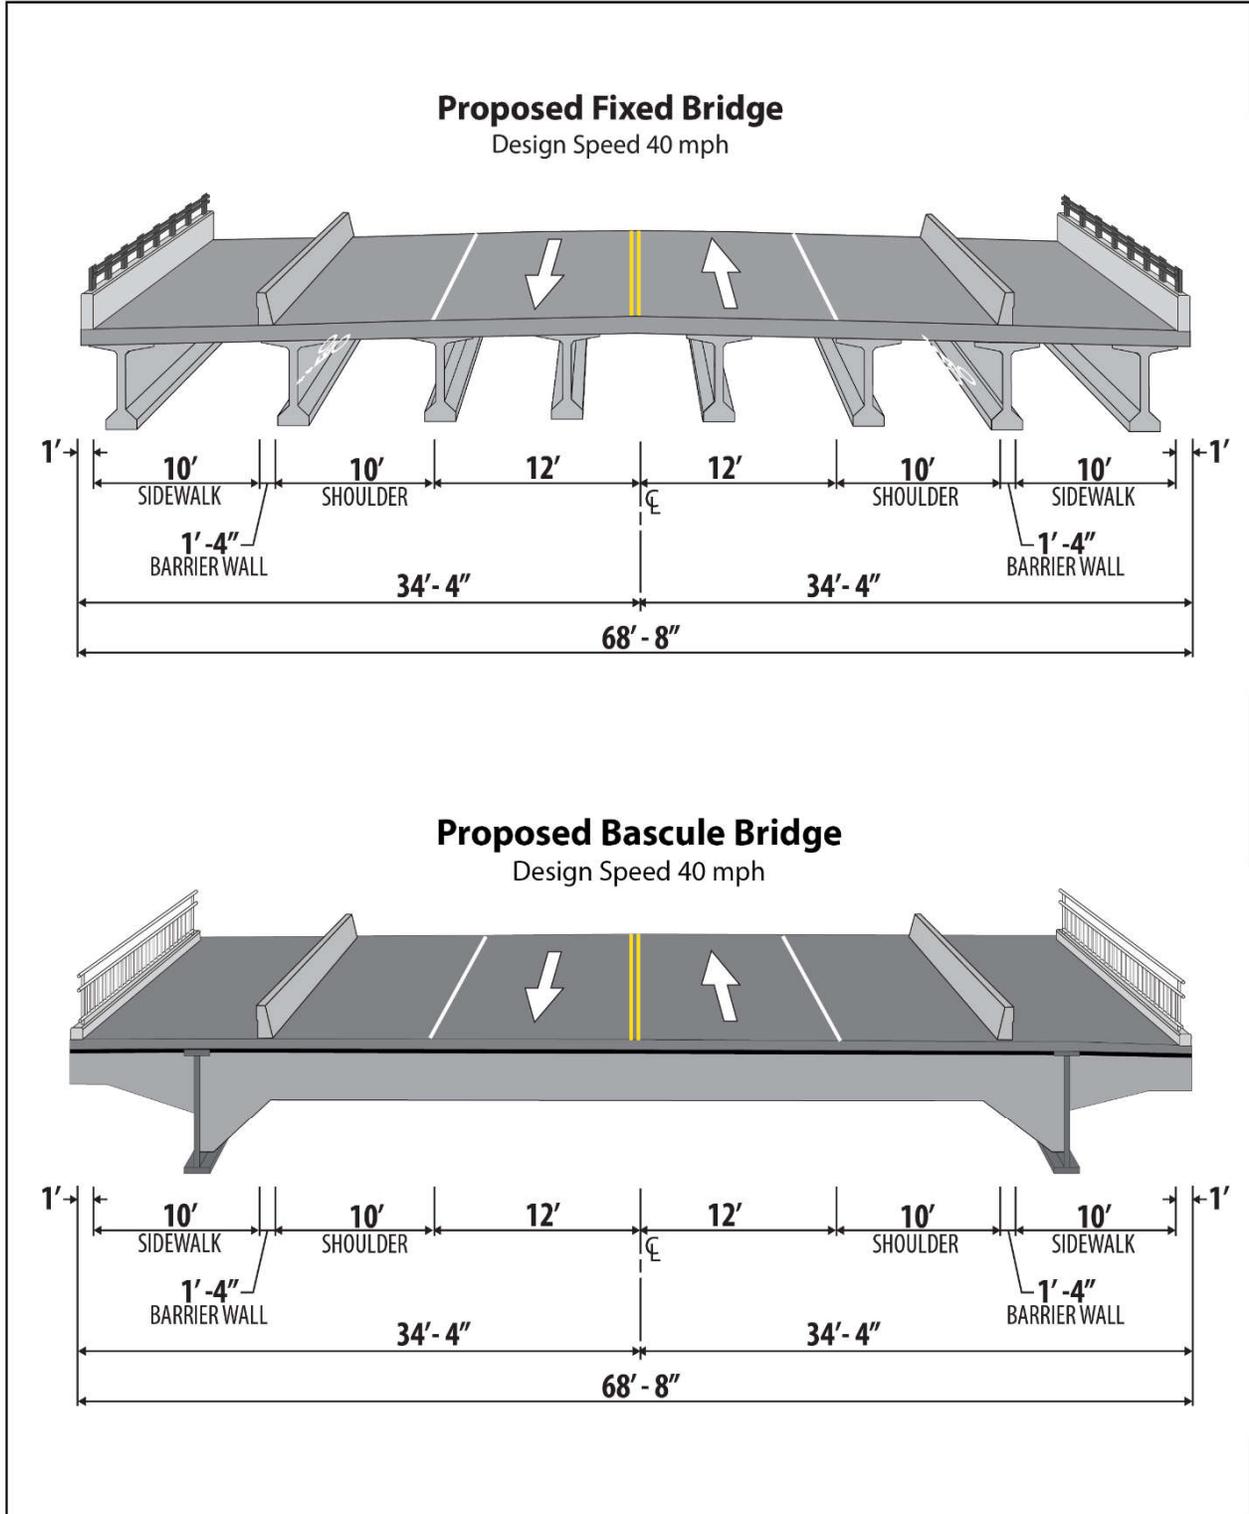
**Figure 2-3: Proposed Build Alternative Typical Section**

Therefore, a new bridge typical section was developed as shown in **Figure 2-3**. This is similar to the original two-lane typical section, except the sidewalk widths were increased from 8 ft to 10 ft., for an overall bridge width of 68-ft 8-inches. The 10-ft sidewalks are consistent with the Ringling Bridge and proposed SR 64 Anna Maria Bridge and offers generous opportunities for bicycle and pedestrian use. The 10-ft width also satisfies a request from Manatee County (email October 10, 2015) for 10-ft sidewalks. This typical section will apply to the 35-ft bascule and 65-ft fixed bridge alternatives. The Evaluation Matrix for the refined two-lane bridges with 10-ft shoulders and 10-ft sidewalks is found in **Table 2-2**. **The alternatives evaluated in Table 2-2 will be carried forward as the Build Alternatives for consideration at a Public Hearing.**

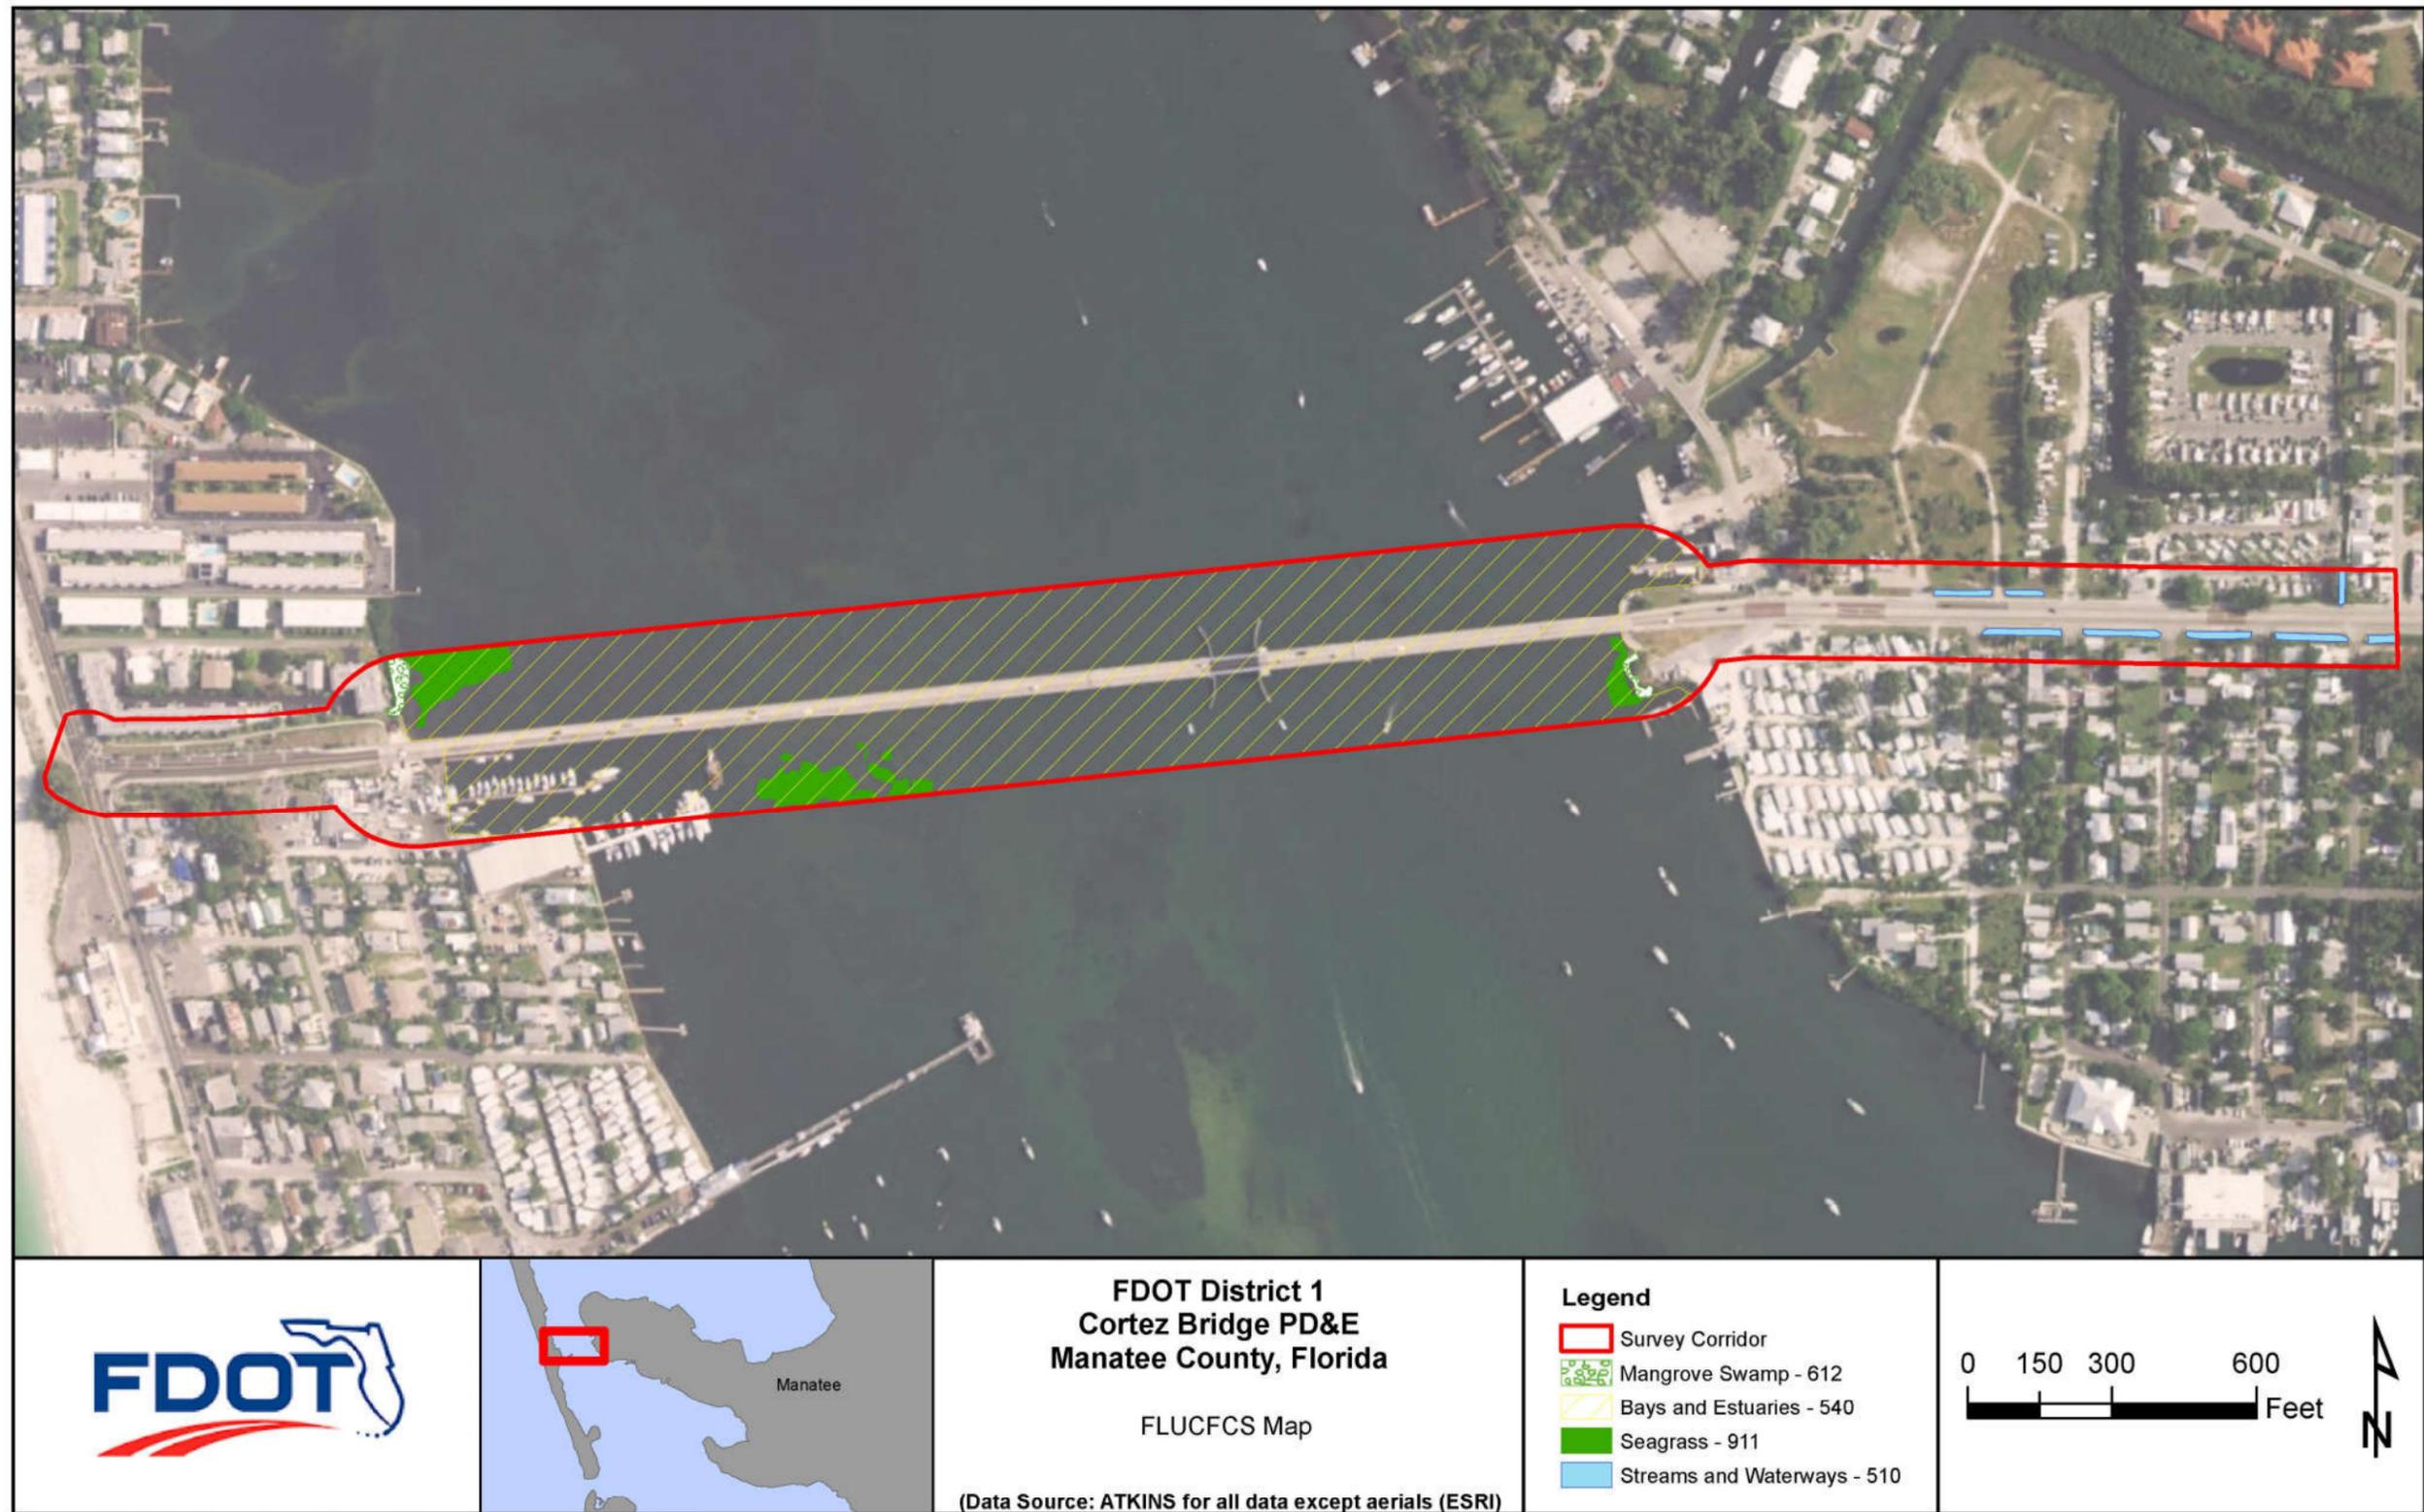
Figure 5-1: FLUCFCS Map

Wetland and marine habitats were evaluated within a study area bounded by SR 789 (Gulf Drive) to the west, 123<sup>rd</sup> Street West to the east, and 200 feet from the centerline of the existing bridge to the north and south. Using the above information, potential wetland, OSW and seagrass areas were identified within the study area. These areas were mapped on aerials, labeled using both the FLUCFCS classification system and corresponding NWI code, and given a unique identifier (Figures 5-1 through 5-3).

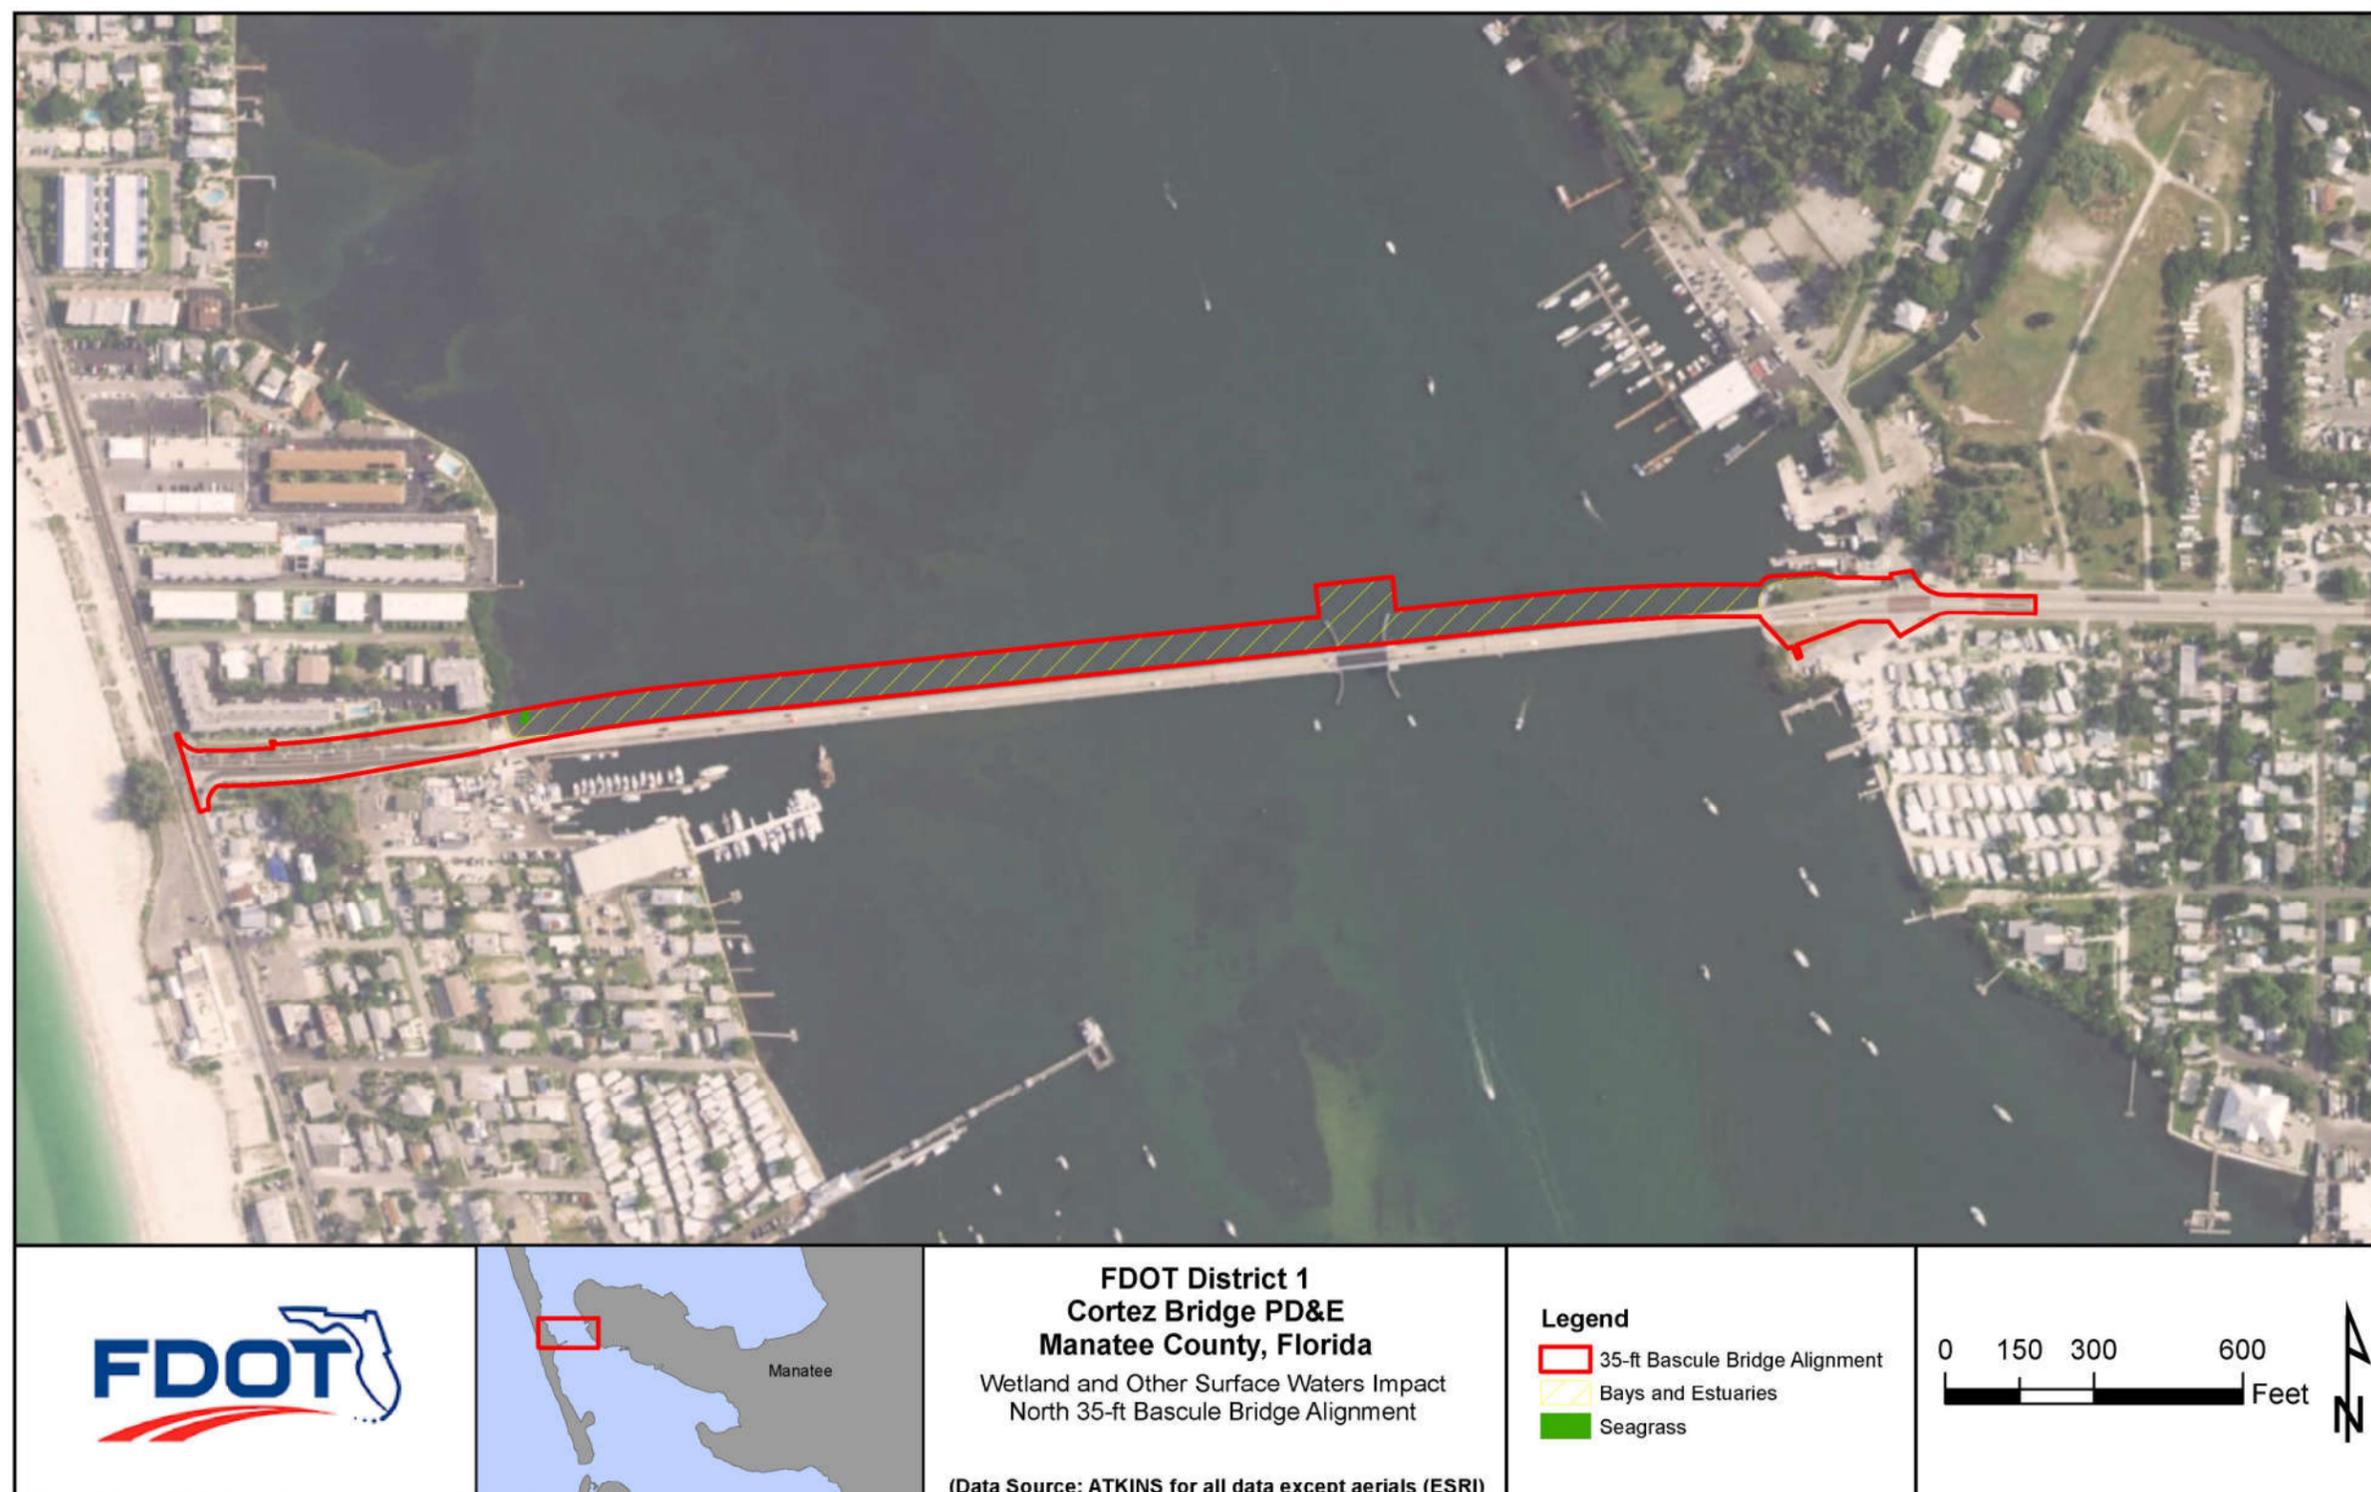
Figure 5-2: Wetland and Other Surface Waters Impact (North 35-ft Bascule Bridge Alignment)

The two Build Alternatives (35-ft Bascule Bridge North Alignment and the 65-ft Fixed Bridge North Alignment) indicate no impacts to mangrove wetlands associated with both the eastern and western shorelines of Anna Maria Sound, as well as adjacent to the eastern terminus of the project corridor. There is no OSW impact anticipated with the 35-ft Bascule Bridge North.

Alignment alternative. There are 0.02 ac. of impacts to OSWs anticipated for the 65-ft Fixed Bridge North Alignment alternative. Both Build Alternatives would impact 0.01 acre of seagrass. Please refer to **Table 5-1** for impacts to wetlands and OSWs associated with the No-Build, and the two Build Alternatives. Shading impacts to seagrasses have been included in this analysis.

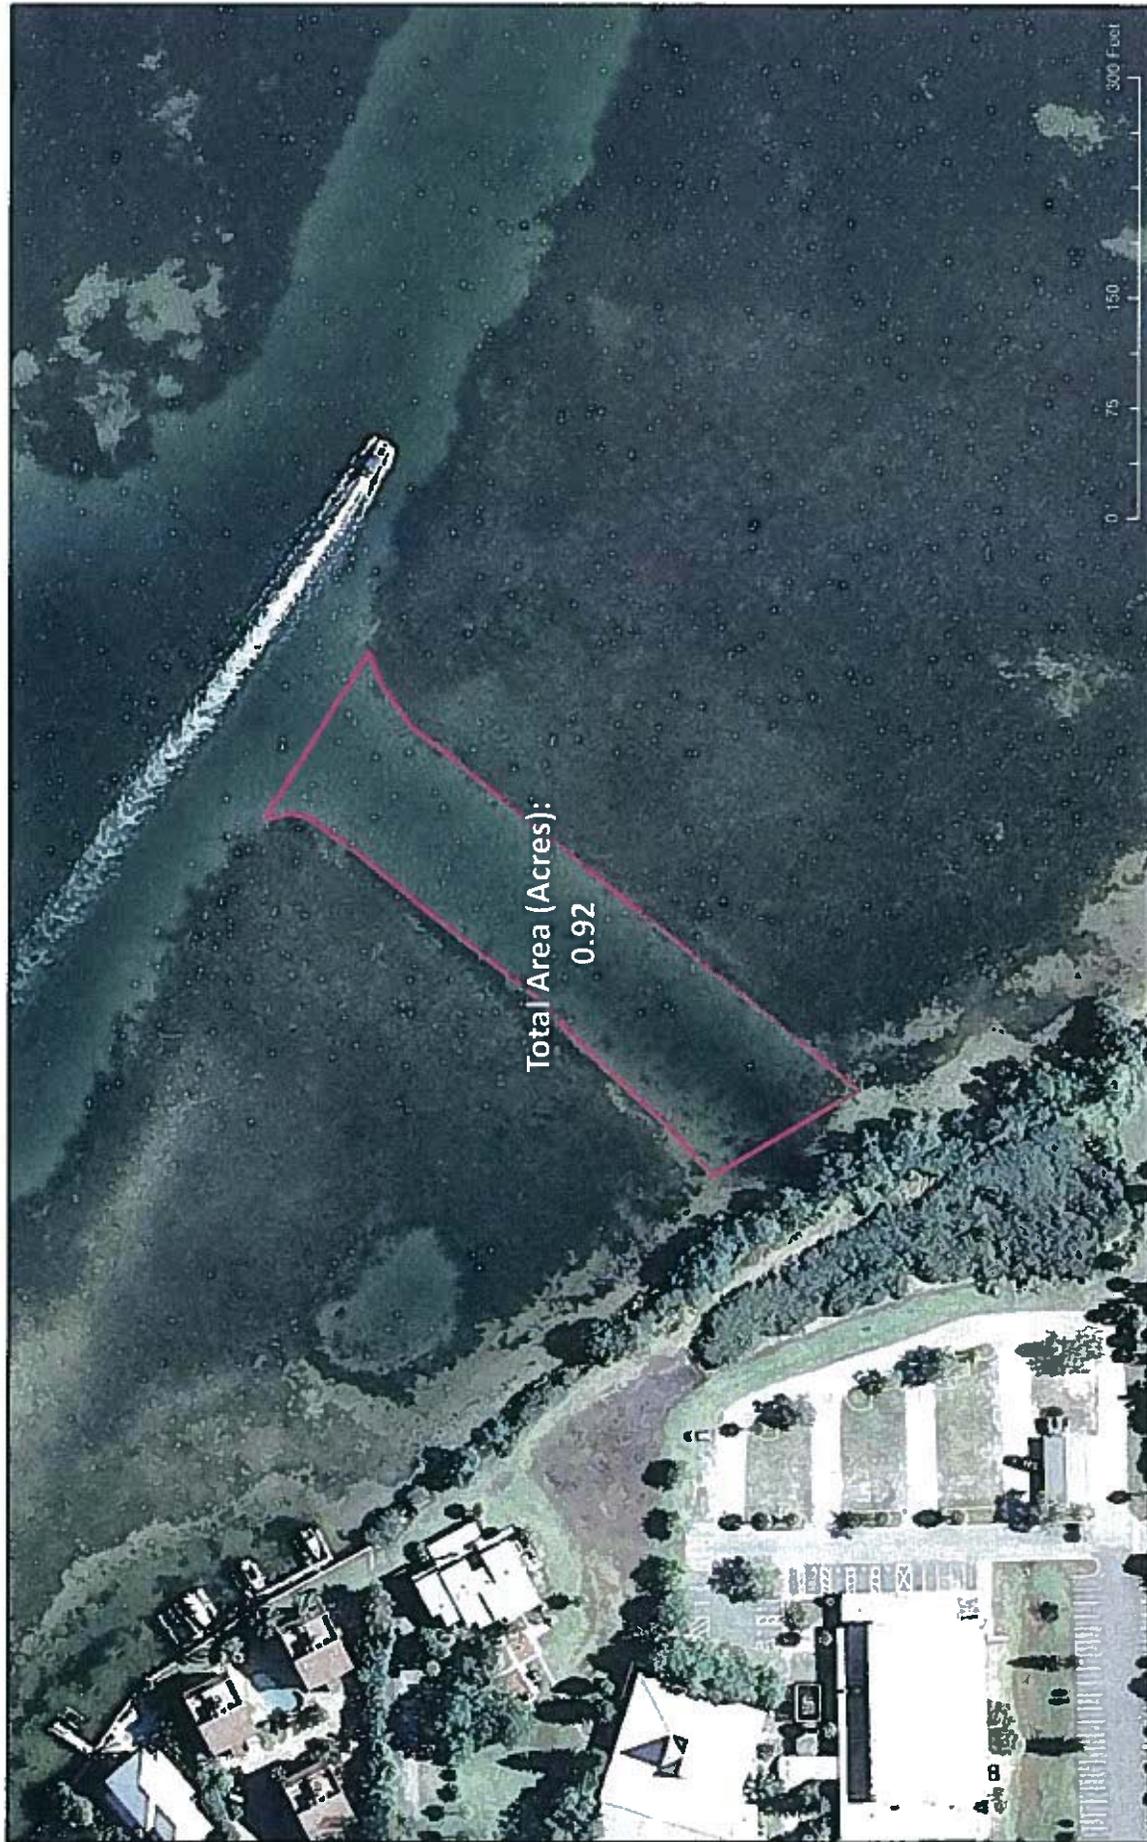
**Figure 3. Potential Seagrass Mitigation Option #1**

Mitigation Option #1 consists of a linear channel that is located northwest of the existing bridge (Figure 3). The channel extends in a northeast direction, beginning approximately 25 feet from the shore and terminating at the navigation channel. Atkins biologists swam the entire channel area. The channel was relatively shallow (estimated at 6 feet) and the substrate consisted of unvegetated, sandy bottom. Sparse sprigs of shoal grass (*Halodule wrightii*) were observed between the shore and the western

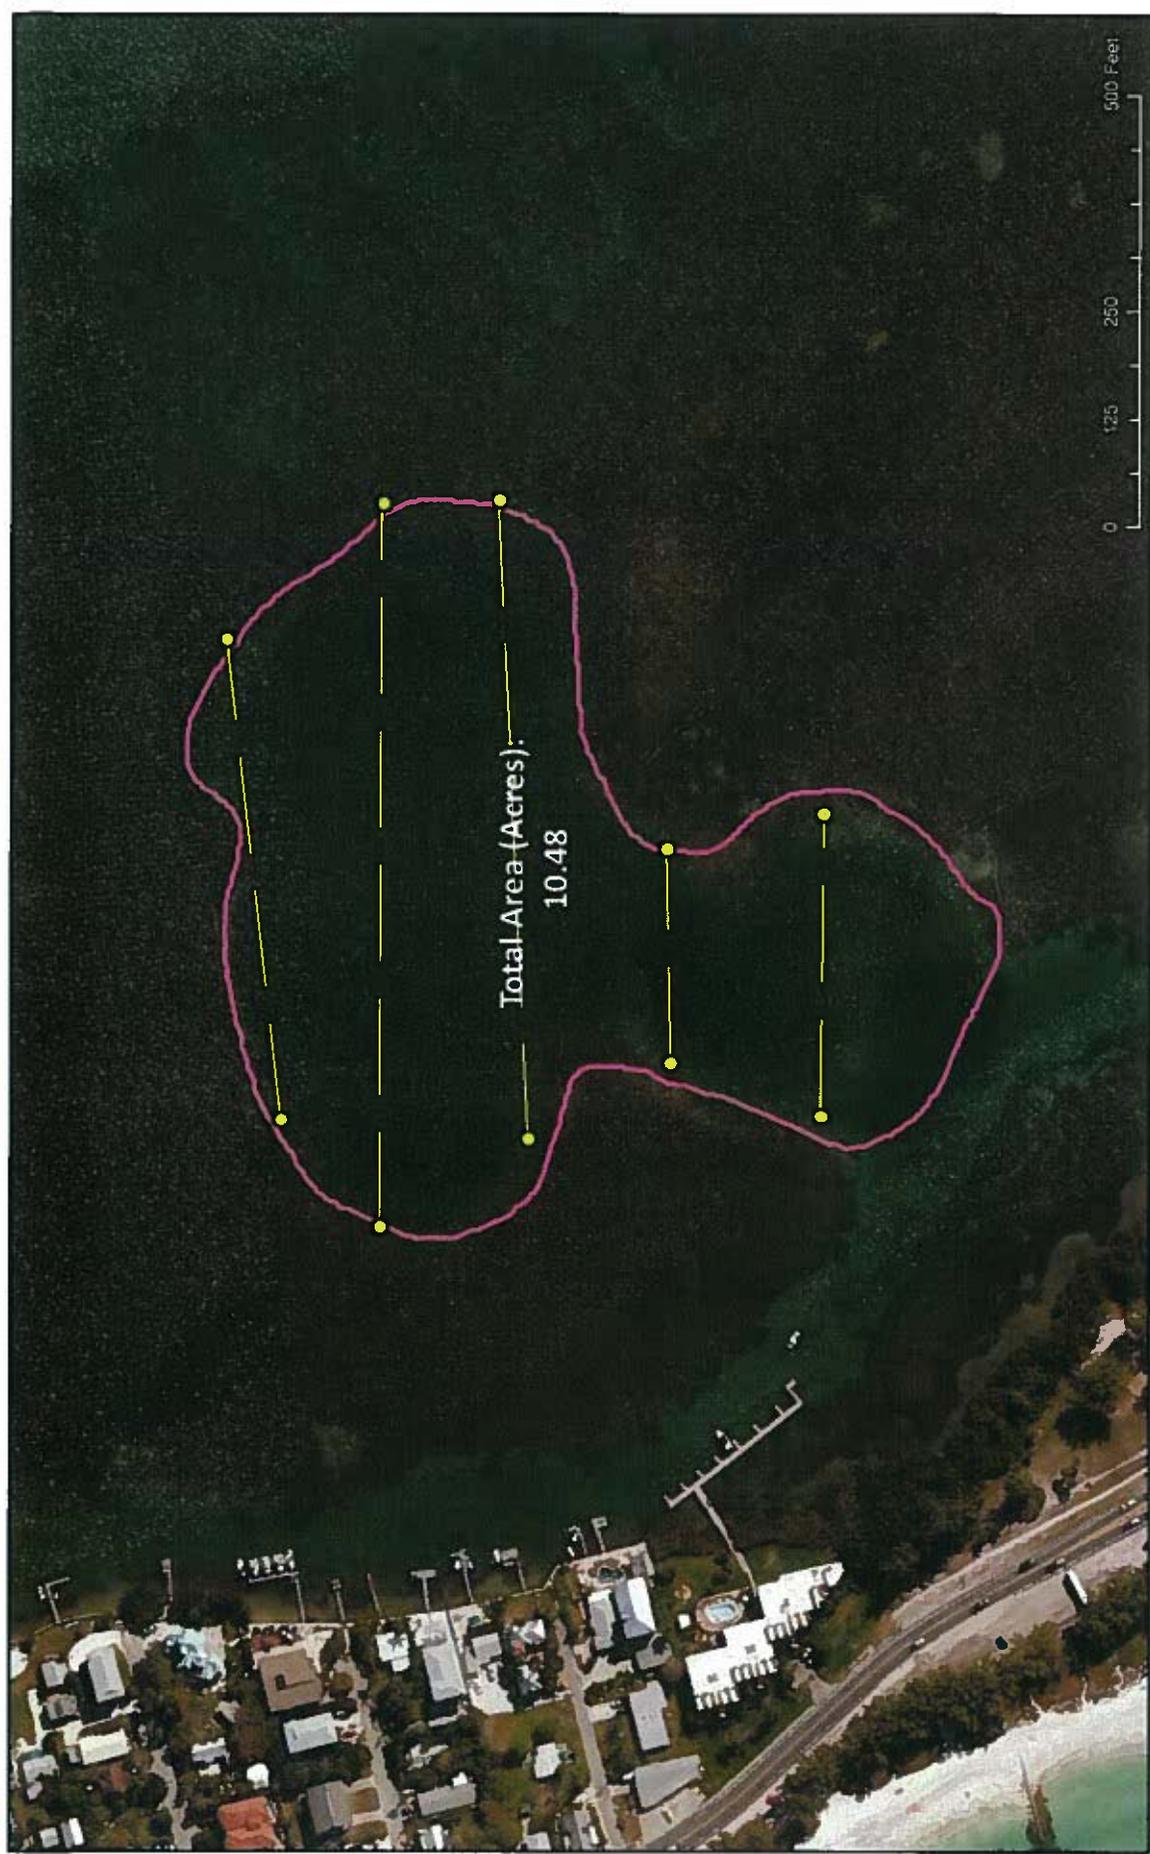
**Figure 4. Potential Seagrass Mitigation Option #2**

Mitigation Option #2 consists of a previously dredged hole located southwest of the Cortez Bridge (Figure 4). This site has a shape that resembles a mushroom, with a large lobe at the northern end and a narrower neck towards the south. To assess the substrate, Atkins biologists conducted five linear directional swims through the site using SCUBA equipment and compass (Figure 4). The northern lobe of the site is occupied by a deep dredge pit. There is a sandy/silty shelf around the edge, which slopes down into a deep pit (estimated at 12 feet deep). Light within the pit is extremely limited and sediments at the bottom of the pit are black, barren, and anoxic.
